NSWC TR 87-328

CORROSION BEHAVIOR OF SiC REINFORCED ALUMINUM ALLOYS

RESEARCH AND TECHNOLOGY DEPARTMENT

25 SEPTEMBER 1987

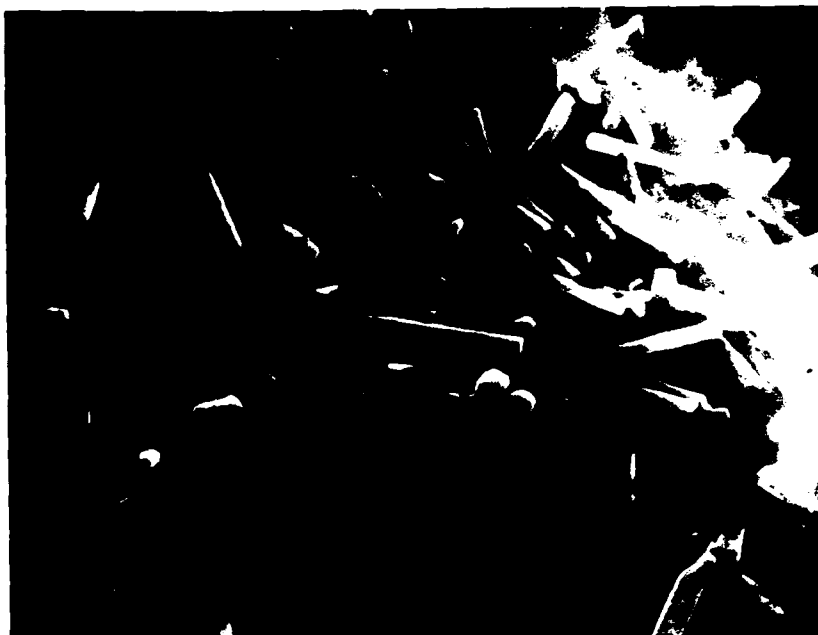
FIGURE 21. SiC WHISKERS FOUND AT THE BOTTOM OF A PIT
ON SiC/AA-2124-T6M (5,000 X)
